64-bit Intel® Xeon® Processor with 800 MHz System Bus (1 MB and 2 MB L2 Cache Versions)

Specification Update

January 2006

Document Number: 302402-020

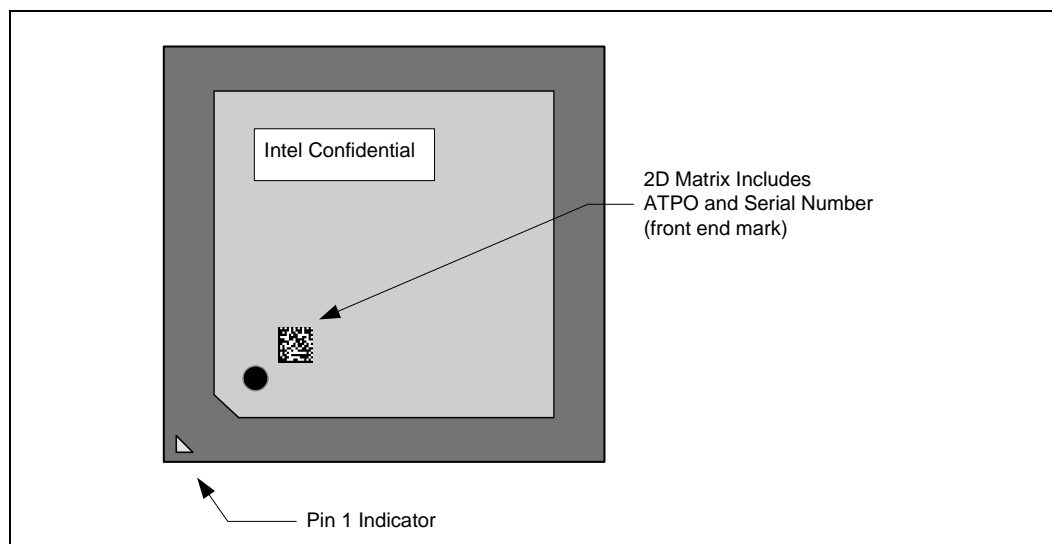
Figure 1. Top-Side Processor Marking Example

64-bit Intel® Xeon® Processor with 800 MHz System Bus (1 MB and 2 MB L2 Cache Versions) Package Markings (604-pin FC-mPGA4 Package)
